**Flood Control Project Maintenance
Levee Inspections**
LMA District Cover Sheet
Spring 2020 Levee Inspection Results

Lake County Watershed Protection District

Spring 2020 Levee Inspection Results

Waterway			Bank	Unit Miles
Unit No. 01 Middle Creek			Left	3.35
	Spring (March - May)	Summer (June - August)	(September - November) Fall	Winter (December - February)
Unit Maintenance Rating (Fall Only)				
Date of Inspection	4/1/2020 - 4/2/2020			
DWR Inspector	Luz Dial			
Accompanied By	Yuliya Osetrova Lake County

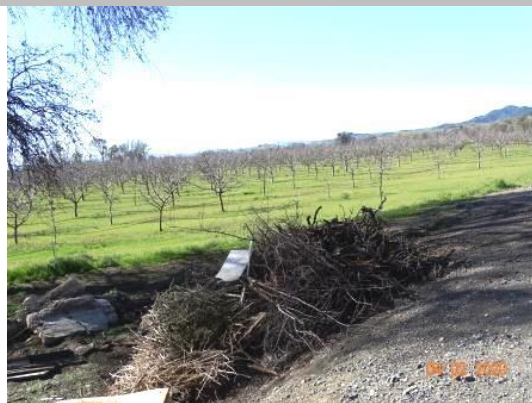
Photo 1 of 1 : SP_2020_NA0009_3_36_20200403_00045.jpg

View of prunings and debris on the landside slope. Spring 2020

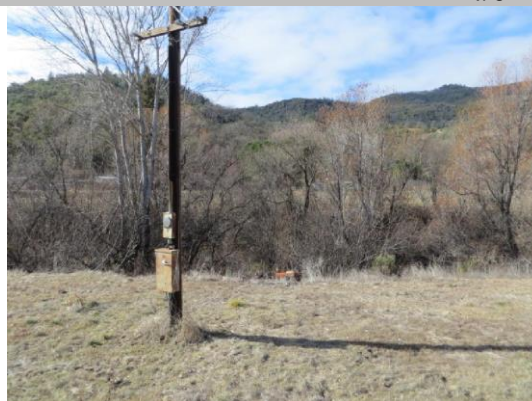
Photo 2 of 3 : UCIP_SP_2020_55696_49781.jpg

Power pole, meter, and pump visible on WS berm.

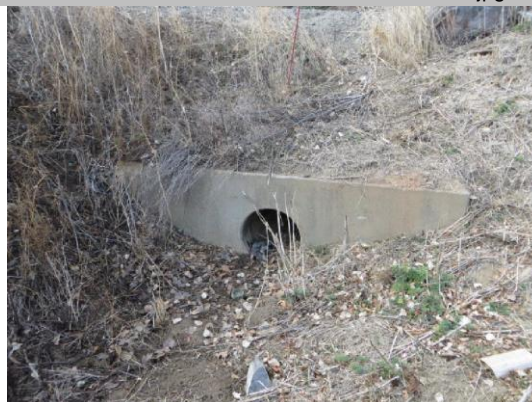
Photo 2 of 3 : UCIP_SP_2020_55693_49784.jpg

Drain pipe visible at concrete headwall on LS toe.

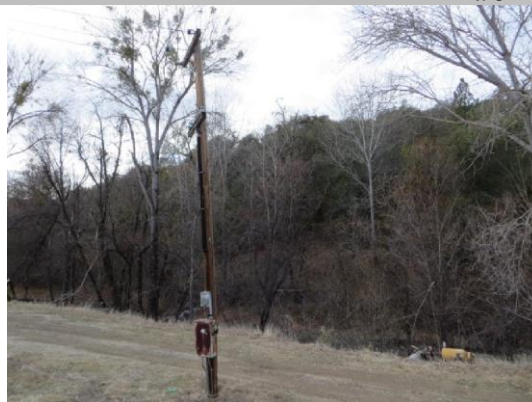
Photo 2 of 3 : UCIP_SP_2020_55697_49788.jpg

Pump, pole, and meter on WS berm.

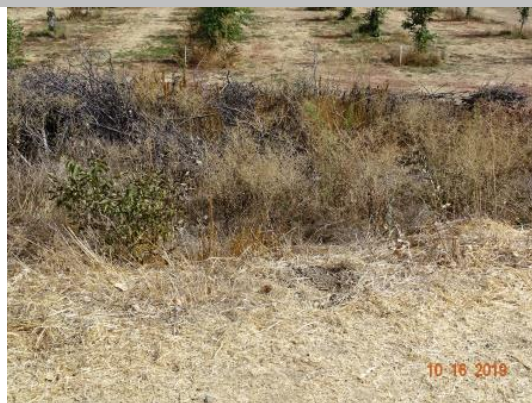
Photo 1 of 1 : SP_2020_NA0009_3_25_20200302_00011.jpg

View of rodent holes on the landside slope. Fall 2019

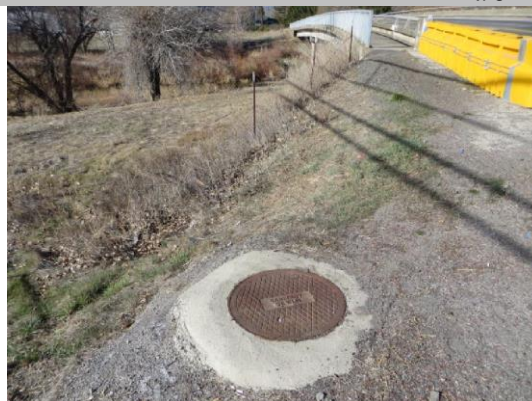
Photo 1 of 1 : UCIP_SP_2020_55700_49870.jpg

Comment Code						
Inspector Comment						
DS_ID:21241 FS_ID:55700 EP_NO: 15865 Repair Type: Non-Urgent Crossing Status: Indicator Found UCIP Comments: 10/16/2019 Record has been updated from No Action Needed to Non-Urgent, unable to confirm alignment; permit recordation notes pipe was never installed from 1983 to 1999 due to property litigation. 03-10-1999 permit owner requested permit stay active. Recommend auditing permit to confirm if pipe was ever installed. (O. Magana - DWR UCIP) FIELD_STRUCT_DESC: 6-inch polyvinyl chloride pressurized sewer line through the levee, 3 feet below the crown. Cutoff wall around pipe at center of levee. Sanitary Sewer manhole on the waterside (WS) shoulder. (6-inch pipe authorized under Permit No. 15865, 1992 - Zachary Calhoun). FS Date: 10/16/2019 3:56:00 PM

SS manhole visible on WS shoulder.

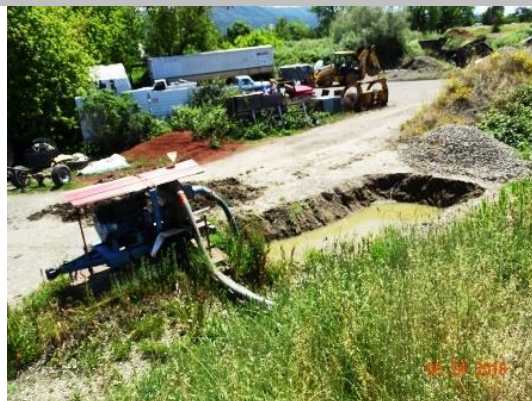
Photo 1 of 2 : SP_2020_NA0009_3_45_20200302_00016.jpg

LM Start	2.10	Rating **	U	Issue No.	45
LM End	2.10	Issue Type +	En	Location *	LS
Category	Earthen Levee			GPS Latitude/Longitude	
				Start	End
Item	Encroachments			39.162198 °	39.162198 °
				-122.915488 °	-122.915488 °
DWR ID	DWR_NA0009_01_s_2019_45				
Comment Code					
DT : Ditch					
Inspector Comment					
The landowner dug a pit approximately 24' x 12' x 3' within the theoretical levee prism and ran a metal pump hose over the crown.

View looking downstream at a storage pit dug into the levee prism.
Spring 2019

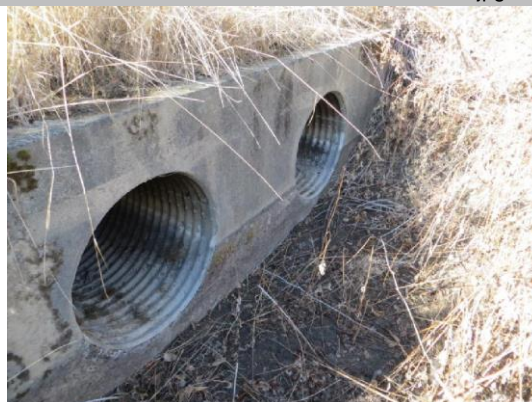
Photo 2 of 3 : UCIP_SP_2020_55702_49852.jpg

Pipe and Concrete headwall visible on LS toe.

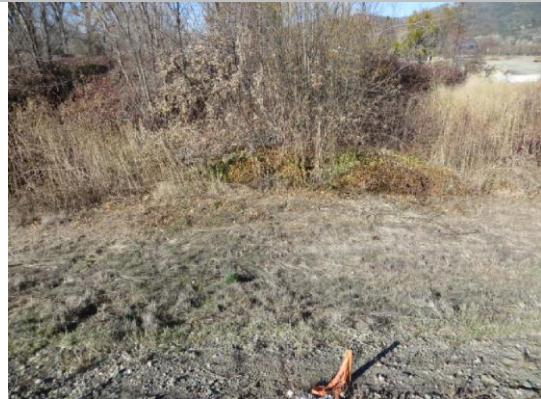
Photo 1 of 3 : UCIP_SP_2020_55705_49862.jpg

Comment Code						
Inspector Comment						
DS_ID:21199 FS_ID:55705 EP_NO: 11460 Repair Type: Non-Urgent Crossing Status: Found UCIP Comments: 10/16/2019 Record remains Non-Urgent, need to audit record to confirm owner. Crossing has been internally inspected under the DWR DMP Phase 1 project. Inspection report is still not available. The UCIP inspection was completed with DWR Inspector, L. Dial, and LMA representative, S. Webb. (O. Magana - DWR UCIP)01/14/2014 Heavy vegetation on LS at inlet should be remove. (W. Wylie - DWR UCIP) FIELD_STRUCT_DESC: 42-inch corrugated metal drainage pipe through the levee, 10 feet below the crown. Flap gate on the waterside (WS) end. Concrete headwall on both ends. (42-inch pipe [HLM 2.35] retained under Automatic Board Order (ABO) issued as Permit No. 11460, 1975 - Robert L. and Lavona Gentry). [Additional Reference(s): DWR Levee Log, 2005. USACE Sacramento O&M Manual 506.2, August 1961, (HLM 2.35), Station C4+90, 42-inch pipe, dwg no. CC-4-4-29, Index Sheet 4: page 4, 38 of 64]. FS Date: 10/16/2019 3:56:00 PM

Heavy vegetation at inlet on LS toe.

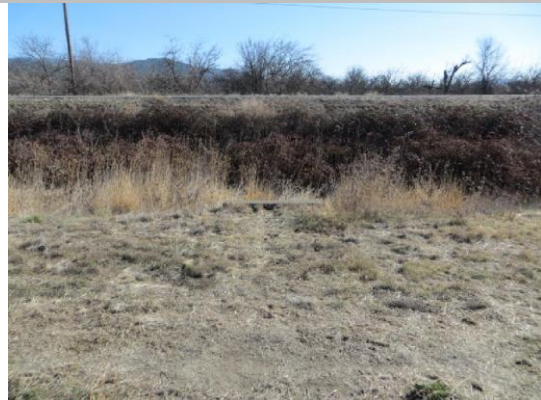
Photo 2 of 3 : UCIP_SP_2020_55705_49861.jpg

Concrete U-shaped headwall on WS berm.

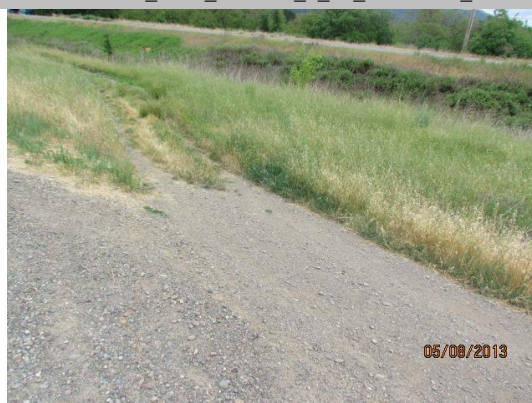
Photo 1 of 1 : SP_2020_NA0009_3_14_20200302_00006.jpg

LM Start	2.36	Rating **	A/W	Issue No.	14
LM End	2.36	Issue Type +	Ma	Location *	WS
Category	Earthen Levee			GPS Latitude/Longitude	
				Start	End
Item	Slope Stability			39.161153 °	39.161153 °
				-122.912740 °	-122.912740 °
DWR ID	DWR_NA0009_01_s_2013_14				
Comment Code					
S3 : Repair the levee slope damaged by vehicle traffic and prevent access where possible.					
Inspector Comment

View of the vehicle erosion along the waterside slope. Spring 2013

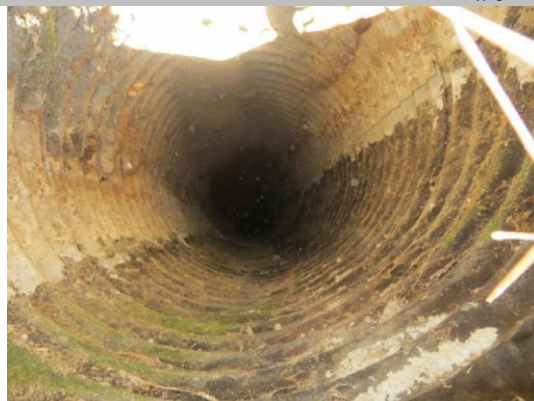
Photo 2 of 3 : UCIP_SP_2020_55707_50041.jpg

Comment Code						
Inspector Comment						
DS_ID:21200 FS_ID:55707 EP_NO: 11458 Repair Type: Urgent Crossing Status: Found UCIP Comments: 10/16/2019 Record remains Urgent due to holes visible inside pipe wall on the WS outlet and no flap gate located on the WS. Currently, there is no way to prevent water from flowing from WS to LS. Flooding occurred during the 2017 highwater event. Need to audit record to confirm owner. Crossing has been internally inspected under the DWR DMP Phase 1 project. Inspection report is still not available. The UCIP inspection was completed with DWR Inspector, L. Dial, and LMA representative, S. Webb. (O. Magana - DWR UCIP)09/06/2018 Inspected this crossing per the request of LMA Rep, Scott Webb. WS pipe does not have a WS closure device and has caused flooding of the roadway due to the flat LS pipe slope and roadway. Classifying Urgent until the flooding risk is reduced by the installation of a WS gate valve (D. Sanoski - DWR UCIP). FIELD_STRUCT_DESC: 36-inch corrugated metal drainage pipe through the levee, 8 feet below the crown. 24-inch by 36-inch drainage drop inlet visible at edge of pavement on Highway 20. Open on the waterside (WS) end. (Pipe retained through the levee under Automatic Board Order (ABO) issued as Permit No. 11458, 1975 - Fernande and Guido Deghetaldi). [Additional Reference(s): DWR Levee Log, 2005]. FS Date: 10/16/2019 3:54:00 PM

Some rust on inside of CMP pipe at WS toe.

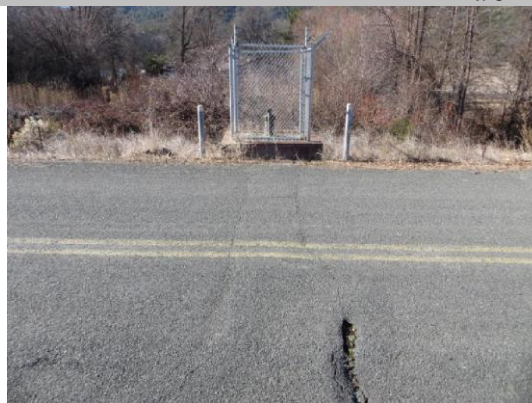
Photo 1 of 3 : UCIP_SP_2020_55714_50046.jpg

Source of pipe visible at well on LS shoulder. Cut in pavement also visible along pipe alignment.

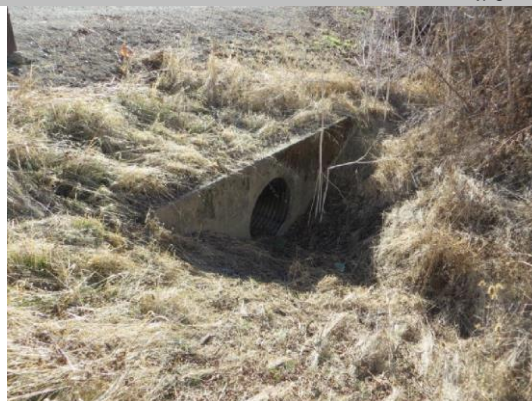
Photo 1 of 3 : UCIP_SP_2020_55717_50322.jpg

Concrete headwall and pipe on LS toe.

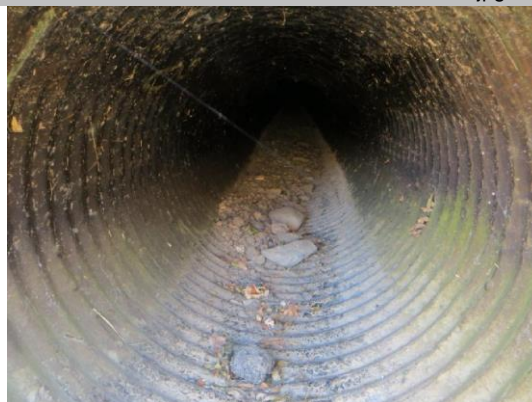
Photo 2 of 3 : UCIP_SP_2020_55717_50321.jpg

Pipe at inlet.

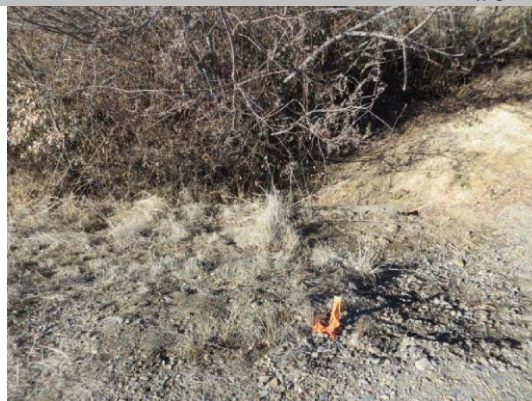
Photo 1 of 3 : UCIP_SP_2020_55718_50326.jpg

Pipe and concrete headwall at LS toe.

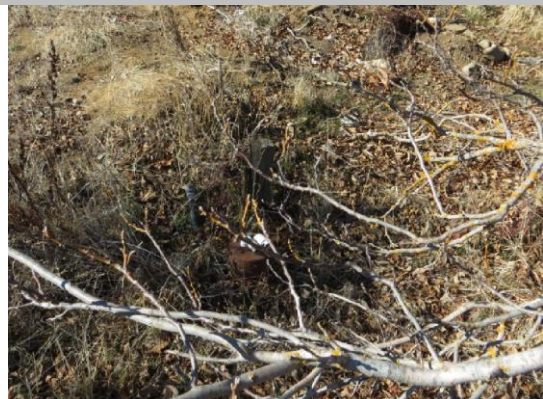
Photo 2 of 3 : UCIP_SP_2020_55719_50329.jpg

Well head visible at LS toe.

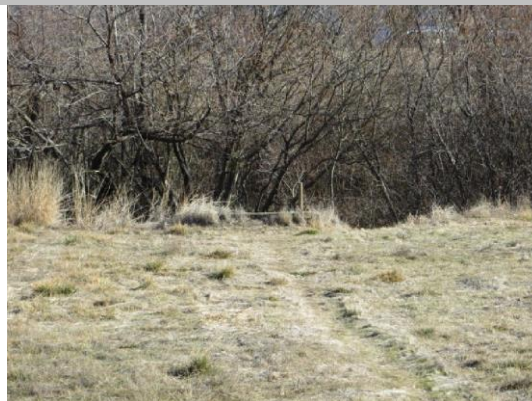
Photo 3 of 3 : UCIP_SP_2020_55723_50387.jpg

Concrete headwall and flapgate visible on waterside berm

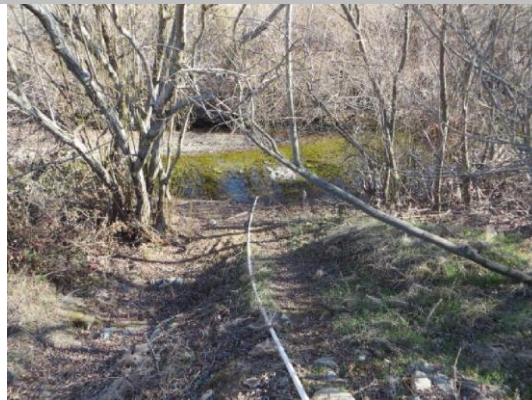
Photo 2 of 3 : UCIP_SP_2020_55720_51181.jpg

Pipe visible just downstream from stormdrain.

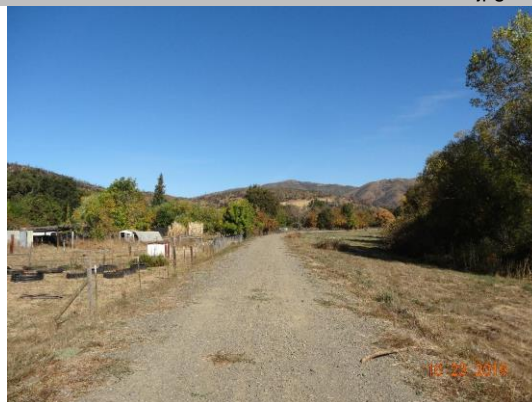
Photo 2 of 3 : UCIP_SP_2020_55729_82581.jpg

Overview of levee crown looking u/s towards pipe crossing.

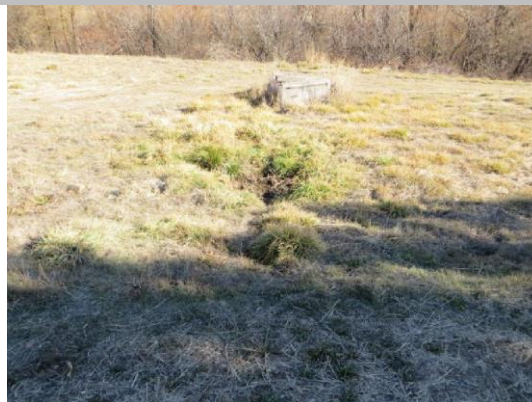
Photo 2 of 3 : UCIP_SP_2020_55728_50392.jpg

Mudpit at WS berm where pipe may be leaking.

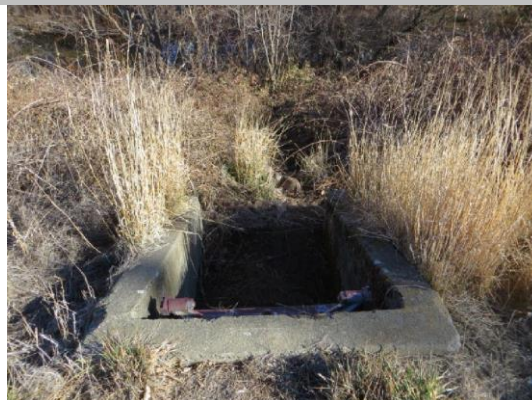
Photo 2 of 3 : UCIP_SP_2020_55730_50410.jpg

Flapgate and concrete headwall on WS berm.

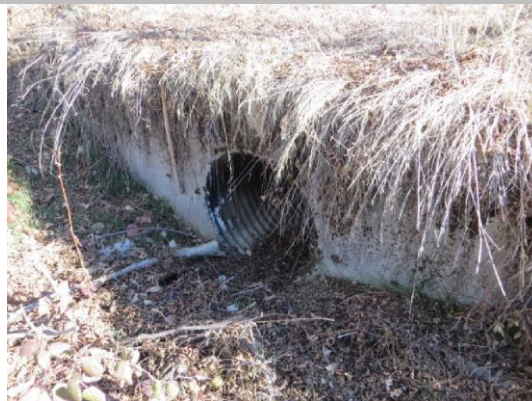
Photo 1 of 3 : UCIP_SP_2020_55740_51202.jpg

Pipe visible at concrete inlet on LS toe.

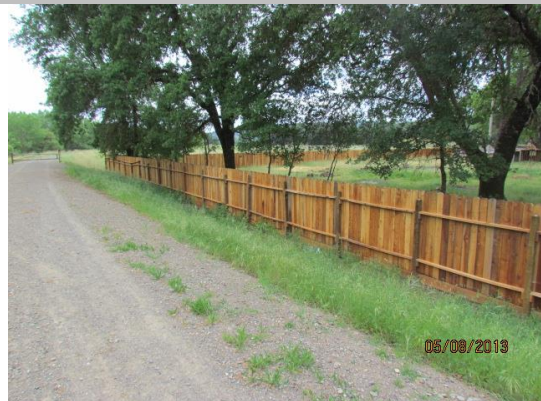
Photo 1 of 1 : SP_2020_NA0009_4_10_20200302_00004.jpg

View of the unauthorized fence along the landside toe. Spring 2013

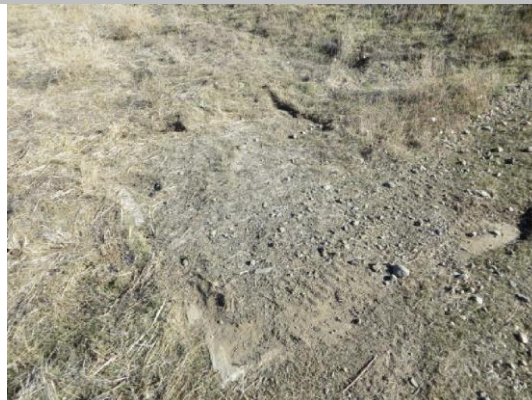
Photo 2 of 3 : UCIP_SP_2020_55741_51213.jpg

6'X8' concrete sump filled in with soil, visible at LS toe.

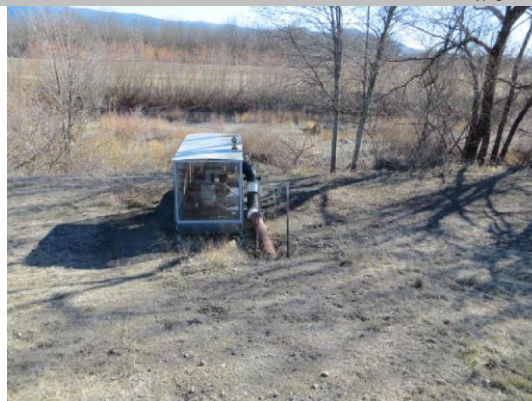
Photo 1 of 3 : UCIP_SP_2020_55742_51242.jpg

Pump and pipe visible on WS toe.

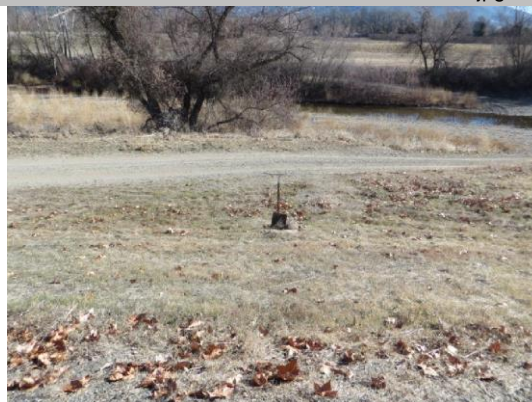
Photo 2 of 3 : UCIP_SP_2020_55865_51249.jpg

T-post at WS toe may indicate location of pipe end. Covered with soil.

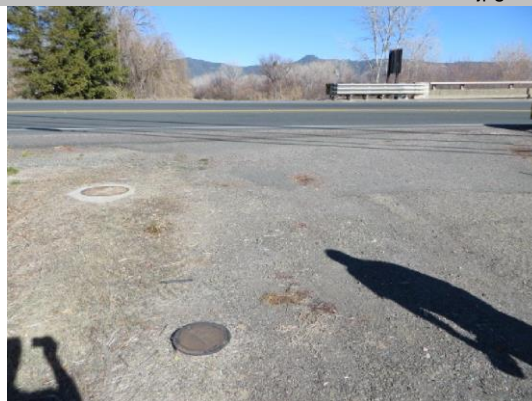
Photo 2 of 3 : UCIP_SP_2020_55752_51262.jpg

Manhole and vent lids visible on LS shoulder.

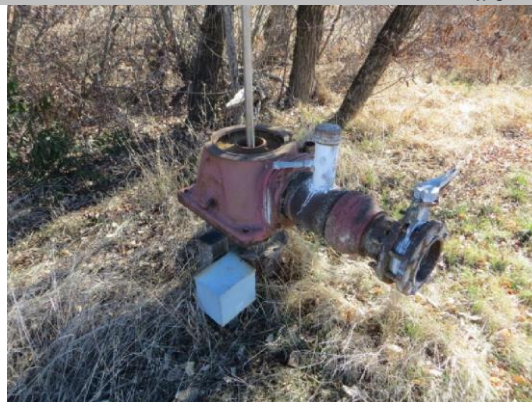
Photo 2 of 3 : UCIP_SP_2020_55753_51273.jpg

Pump and pipe on WS berm with butterfly valve.

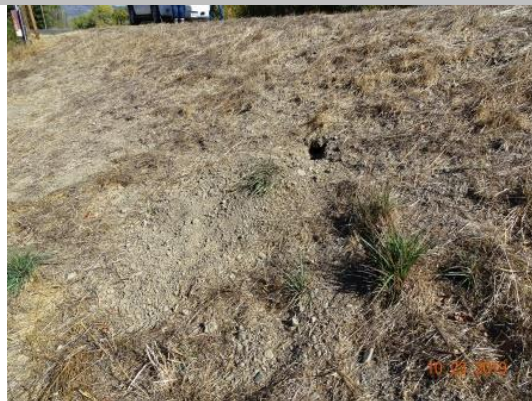
Photo 1 of 2 : SP_2020_NA0009_4_30_20200302_00009.jpg

View looking upstream at animal holes on the landside slope. Fall 2019

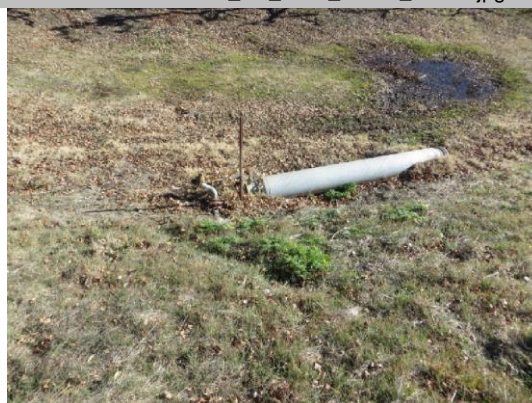
Photo 2 of 3 : UCIP_SP_2020_55768_51521.jpg

Filter, pipe, and valve visible on LS toe.

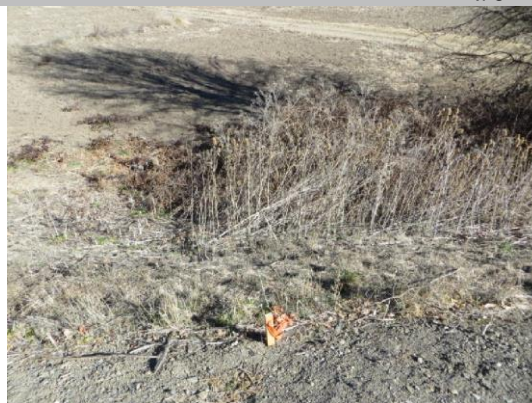
Photo 1 of 3 : UCIP_SP_2020_55769_51542.jpg

Pipe visible at LS toe covered with vegetation.

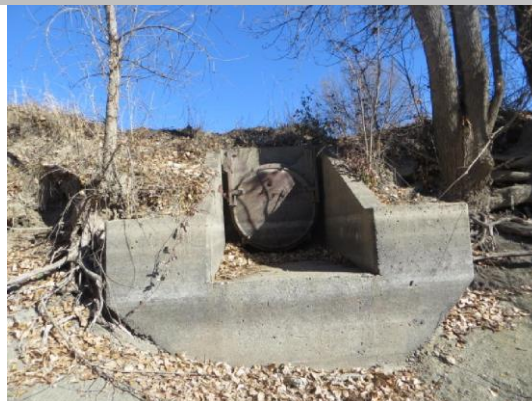
Photo 3 of 3 : UCIP_SP_2020_55769_51540.jpg

Concrete headwall and flapgate visible at WS berm.

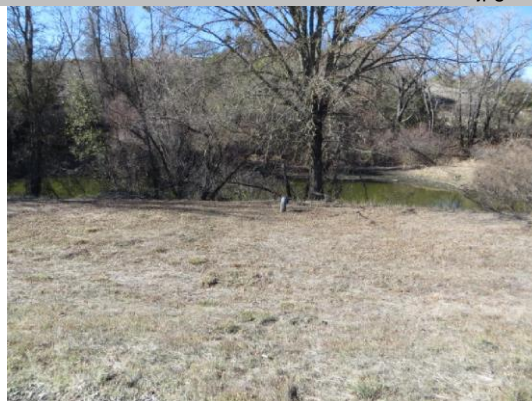
Photo 2 of 3 : UCIP_SP_2020_55770_51561.jpg

Pipe and concrete pad visible off WS toe on WS berm.

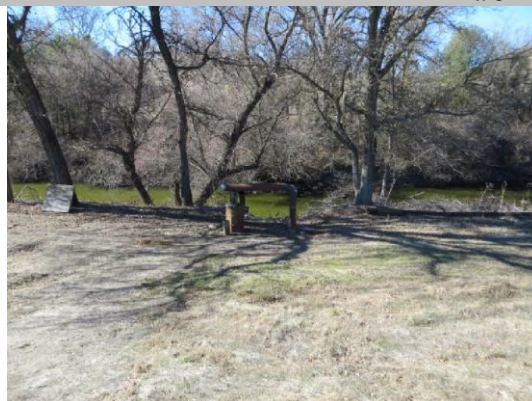
Photo 1 of 3 : UCIP_SP_2020_55767_51582.jpg

Pipe and pump pad visible off WS toe.

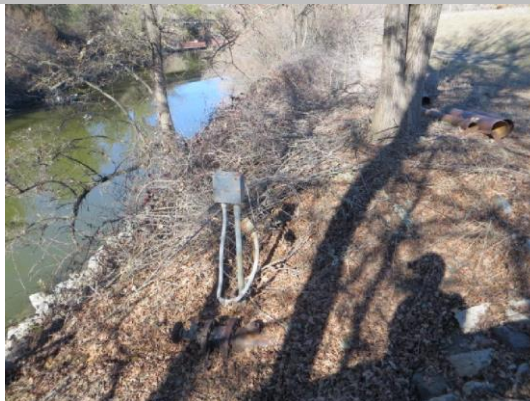
Photo 3 of 3 : UCIP_SP_2020_55767_51580.jpg

Electrical conduit visible on WS berm.

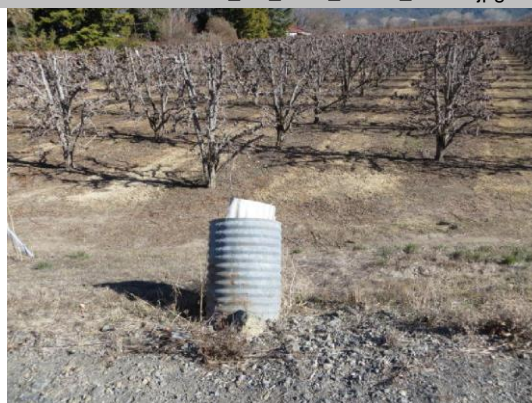
Photo 2 of 3 : UCIP_SP_2020_55775_51586.jpg

Siphon at LS shoulder inside 24-inch CMP riser.

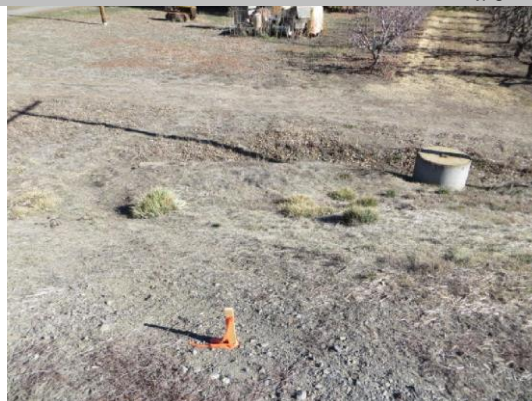
Photo 1 of 3 : UCIP_SP_2020_55778_51591.jpg

Concrete headwall visible next to concrete standpipe on LS toe.

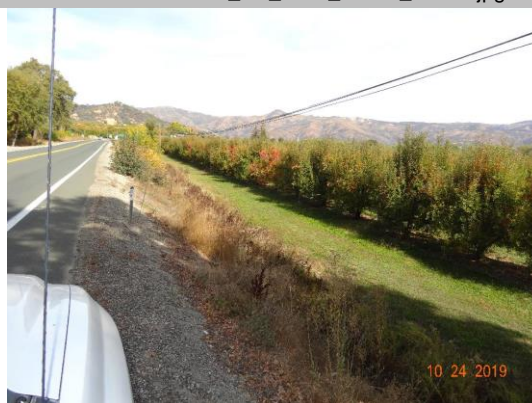
Photo 2 of 3 : UCIP_SP_2020_55781_82826.jpg

LS view: overview of LS.

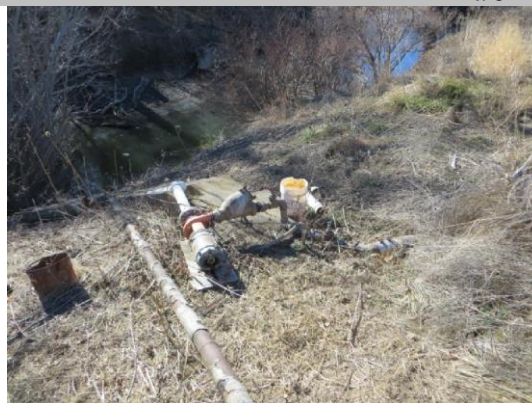
Photo 1 of 3 : UCIP_SP_2020_55783_51622.jpg

Pump at concrete pad on WS berm.

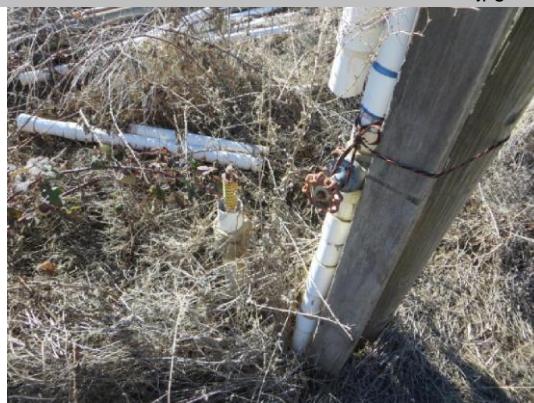
Photo 3 of 3 : UCIP_SP_2020_55783_51620.jpg

filler valves on LS toe.

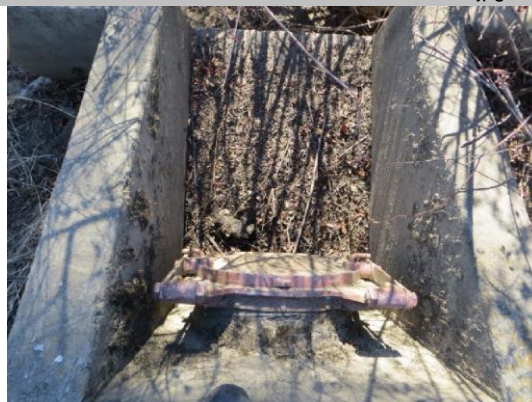
Photo 2 of 3 : UCIP_SP_2020_55784_51641.jpg

Headwall and flapgate on WS berm.

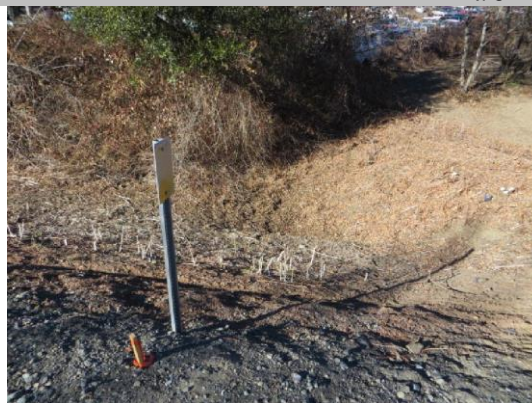
Photo 1 of 3 : UCIP_SP_2020_55785_51646.jpg

Flasher on crown marks pipe location.

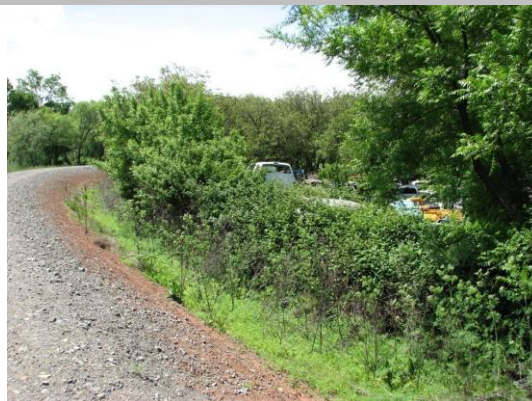
Photo 1 of 1 : SP_2020_NA0009_5_13_20200302_00004.jpg

5/2/2016: Vehicle junk yard behind fence covered in dense growth of bushes and vines.

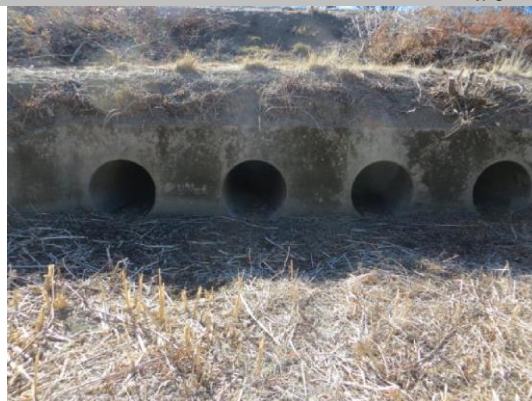
Photo 1 of 3 : UCIP_SP_2020_55787_51665.jpg

Pipe and headdwall on LS toe.

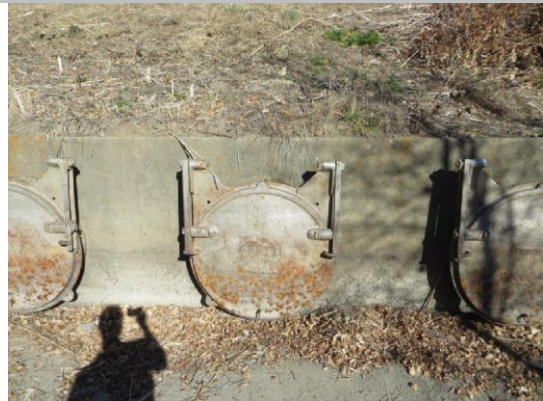
Photo 3 of 3 : UCIP_SP_2020_55787_51663.jpg

Flapgate and headwall on WS toe.

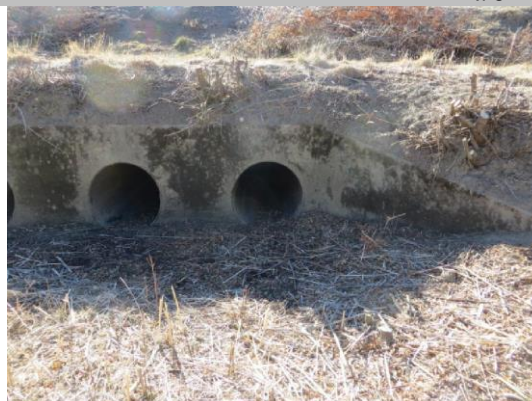
Photo 1 of 3 : UCIP_SP_2020_55789_51671.jpg

Pipe and concrete headwall on LS toe.

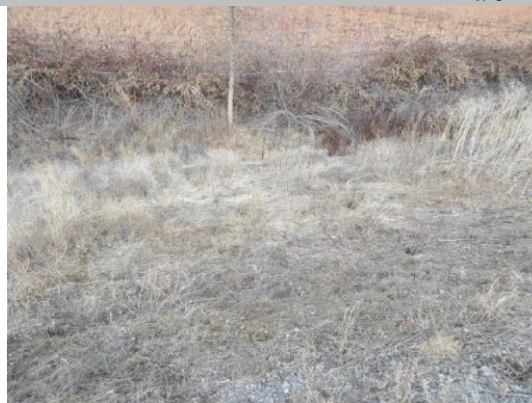
Photo 1 of 3 : UCIP_SP_2020_55812_49793.jpg

Concrete headwall visible on LS toe.

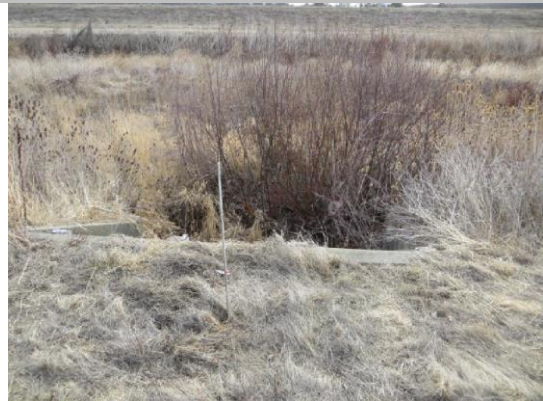
Photo 3 of 3 : UCIP_SP_2020_55812_49791.jpg

Concrete headwall visible on WS berm.

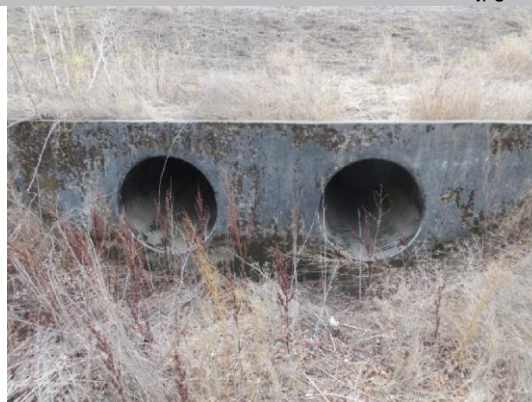
Photo 2 of 3 : UCIP_SP_2020_55813_49796.jpg

Concrete headwall and inlet visible on LS toe.

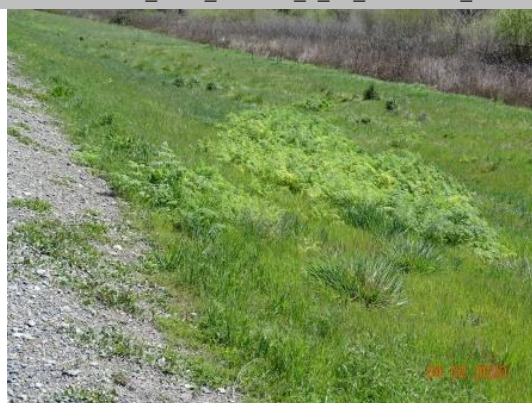
Photo 1 of 1 : SP_2020_NA0009_6_17_20200403_00023.jpg

View of wild growth on the waterside slope. Spring 2020

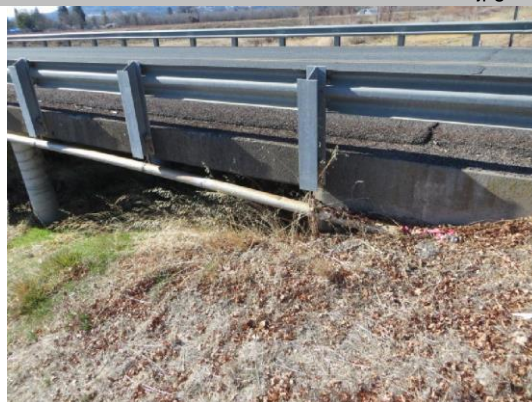
Photo 2 of 3 : UCIP_SP_2020_55814_49750.jpg

Pipe visible on upstream side of bridge.

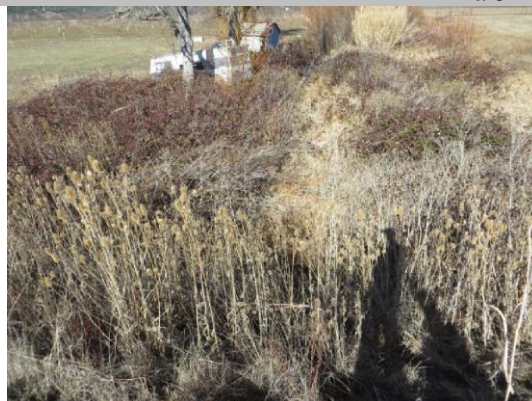
Photo 1 of 3 : UCIP_SP_2020_55811_49754.jpg

Drainage canal at inlet on LS toe.

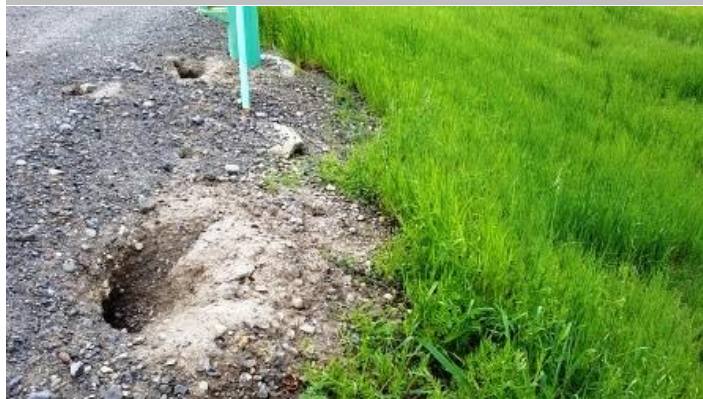
Photo 1 of 1 : SP_2020_NA0009_6_26_20200302_00007.jpg

View of rodent holes with animal activity near the gate. Spring 2019

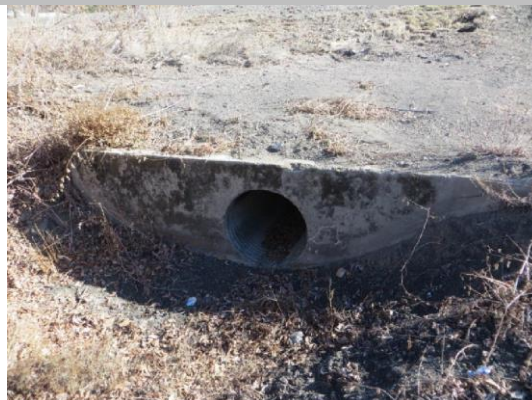
Photo 2 of 3 : UCIP_SP_2020_55816_49761.jpg

Concrete headwall and drainpipe visible at LS toe.

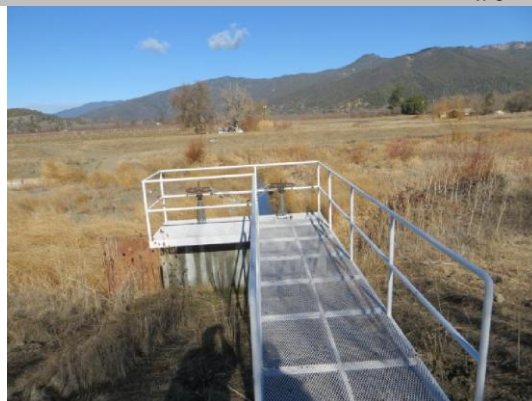
Photo 1 of 3 : UCIP_SP_2020_55848_49712.jpg

Slide gate at steel walkway on WS toe.

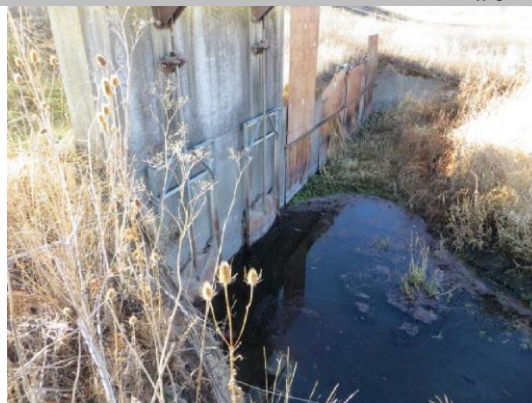
Photo 3 of 3 : UCIP_SP_2020_55848_49710.jpg

Slide gate at concrete headwall on WS toe.

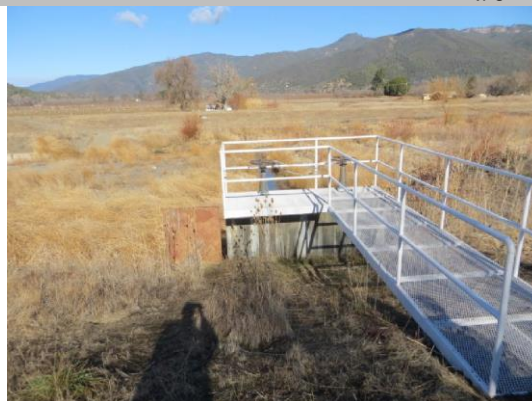
Photo 1 of 3 : UCIP_SP_2020_55849_49682.jpg

Slide gate on steel walkway at WS toe.

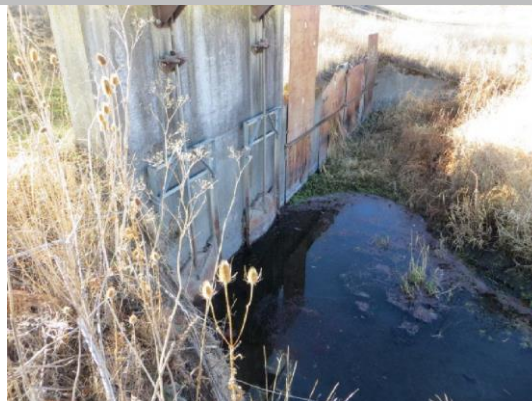
Photo 3 of 3 : UCIP_SP_2020_55849_49680.jpg

Slide gate visible at concrete headwall on WS toe.

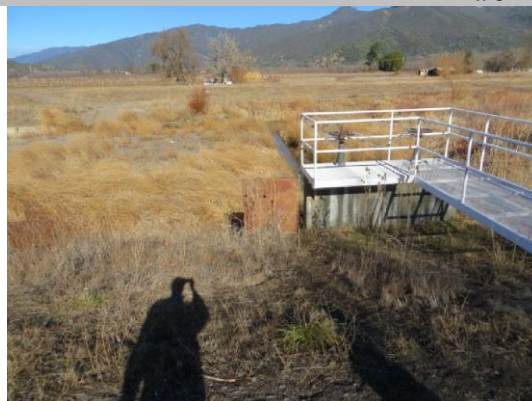
Photo 1 of 3 : UCIP_SP_2020_55853_49666.jpg

Steel slide gate visible at concrete headwall on WS toe.

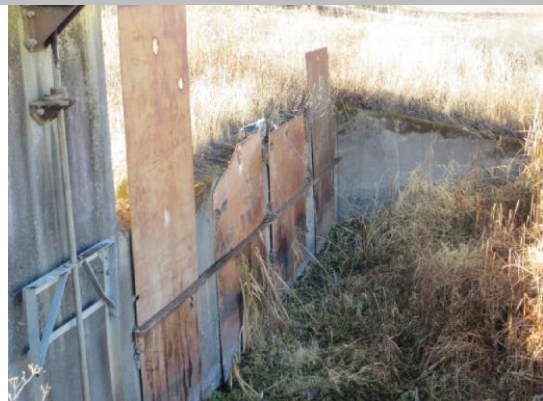
Photo 3 of 3 : UCIP_SP_2020_55853_49664.jpg

Steel slide gate visible at concrete headwall on WS toe.

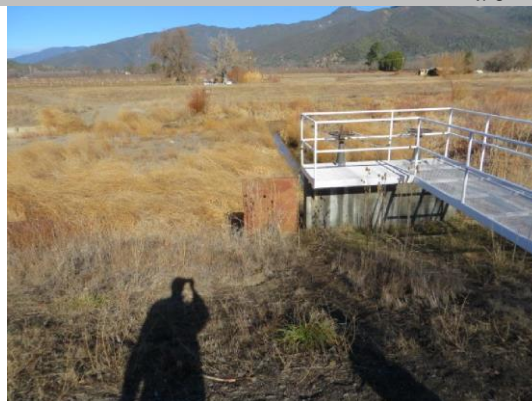
Photo 1 of 3 : UCIP_SP_2020_55851_49634.jpg

Steel plate slide gate visible at headwall on WS toe.

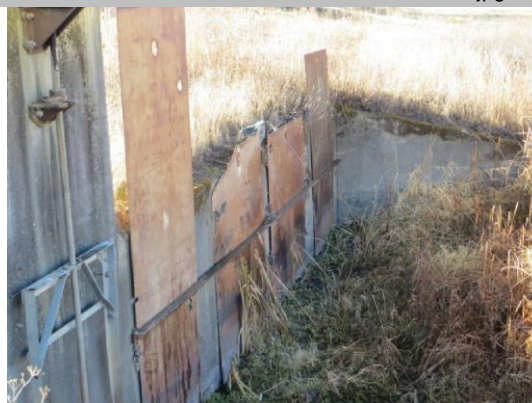
Photo 3 of 3 : UCIP_SP_2020_55851_49632.jpg

Steel plate slide gate visible at headwall on WS toe.

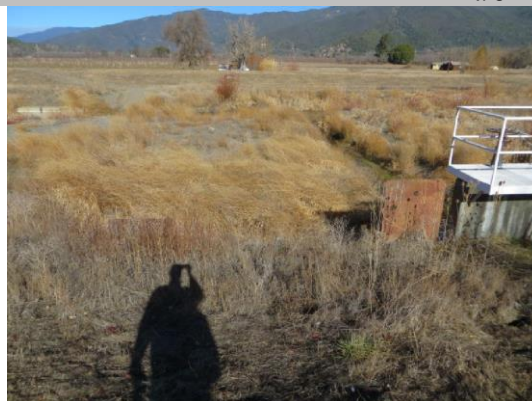
Photo 1 of 3 : UCIP_SP_2020_55854_49622.jpg

Metal slide gate visible at concrete headwall on WS toe.

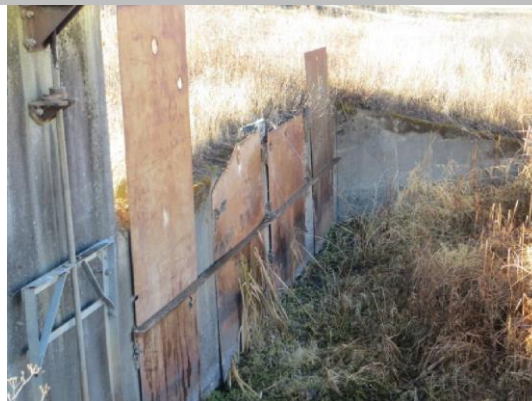
Photo 3 of 3 : UCIP_SP_2020_55854_49620.jpg

Metal slide gate visible at concrete headwall on WS toe.

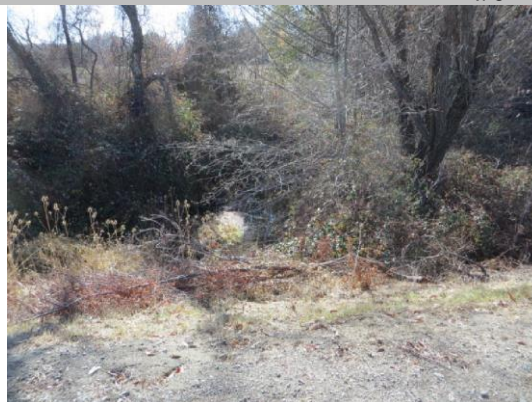
Photo 2 of 3 : UCIP_SP_2020_55341_49609.jpg

Concrete headwall on LS toe.

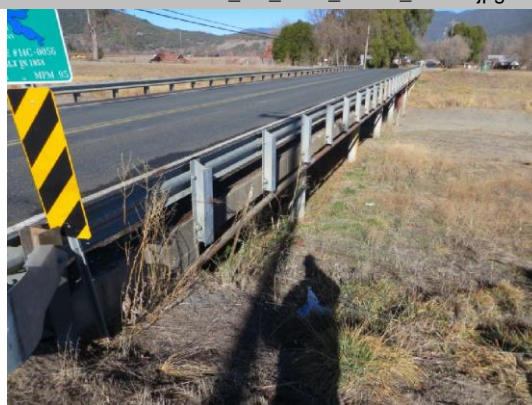
Photo 1 of 3 : UCIP_SP_2020_55818_49593.jpg

Aluminum irrigation pipe visible on upstream side of bridge.

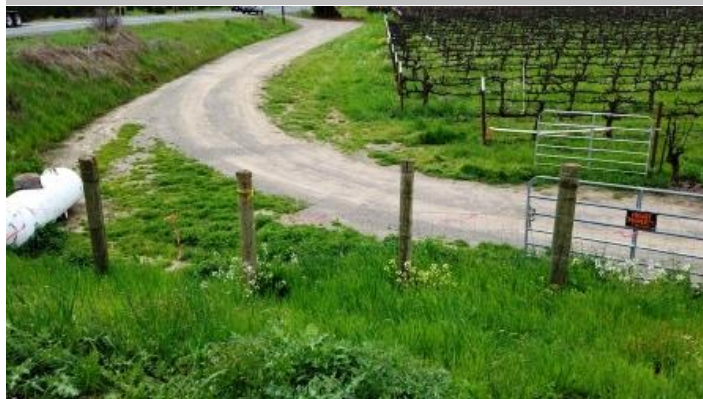
Photo 1 of 1 : SP_2020_NA0009_7_22_20200302_00012.jpg

View of landowner's fence posts placed at levee toe. Spring 2019
